REPORT R-1678

UNITED STATES ARMY

FRANKFORD ARSENAL

FRACTURE CHARACTERISTICS OF ALUMINUM ALLOYS
WETTED WITH LIQUID ZINC AMALGAM

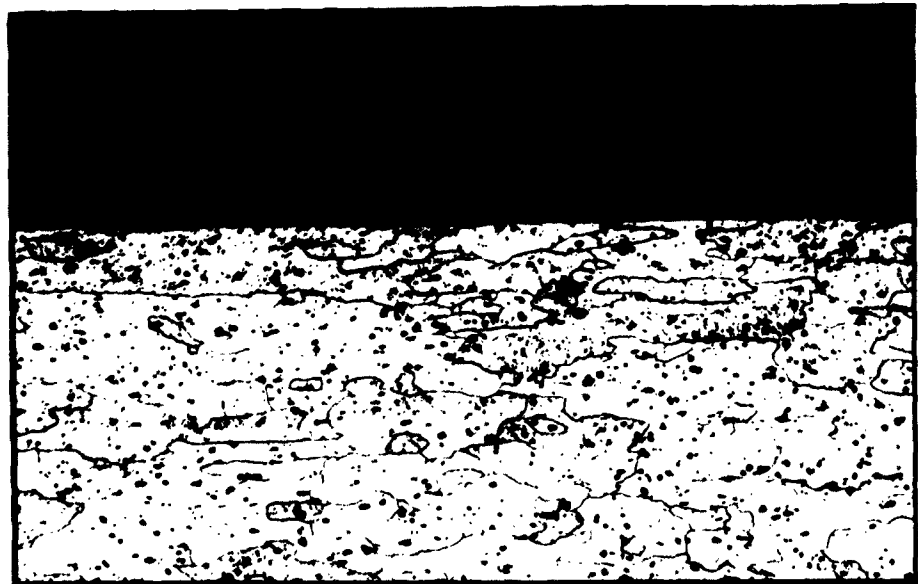
Figure 8. Photomicrographs depicting edge of 1/16 in. thick 2024 T-3 aluminum which had been wetted with 27% Zn - Hg amalgam and probe and then dewetted immediately. Transverse to rolling direction. Magnification 200X.

Specimens from alloy 2024 T-3 were wetted with amalgam using the ultrasonic probe and were then dewetted at increasing intervals and subjected to microscopic examination to detect extent of amalgam penetration. As shown in the photomicrographs (see figures 8 through 14) there was a physical, dissolution of the aluminum surface by the amalgam which progressed with time.

This attack appeared to take the form of penetration of amalgam and lifting out of whole grains. Generally, penetration was not deep. The rate of dissolution was not very rapid; after 72 hours wetted exposure the measured depth of penetration was approximately 0.0012 inch. However, as noted earlier, only a short time, on the order of 60 minutes, was required to cause the wetted fracture strength to drop to fairly low values. Microscopic examination of specimens exposed for this time showed but a slight roughening of the surface. The condition measured less than 0.0001 inch in depth.

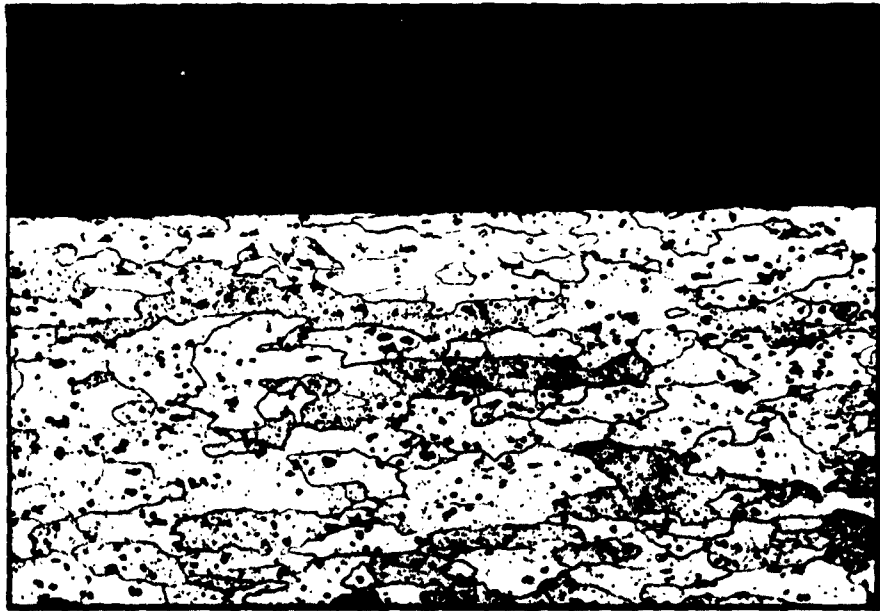
Figure 9. Photomicrographs depicting edge of 1/16 in. thick 2024 T-3 aluminum which had been wetted with 27% Zn - Hg amalgam and held two hours unstressed before dewetting. Transverse to rolling direction. Magnification 200X.

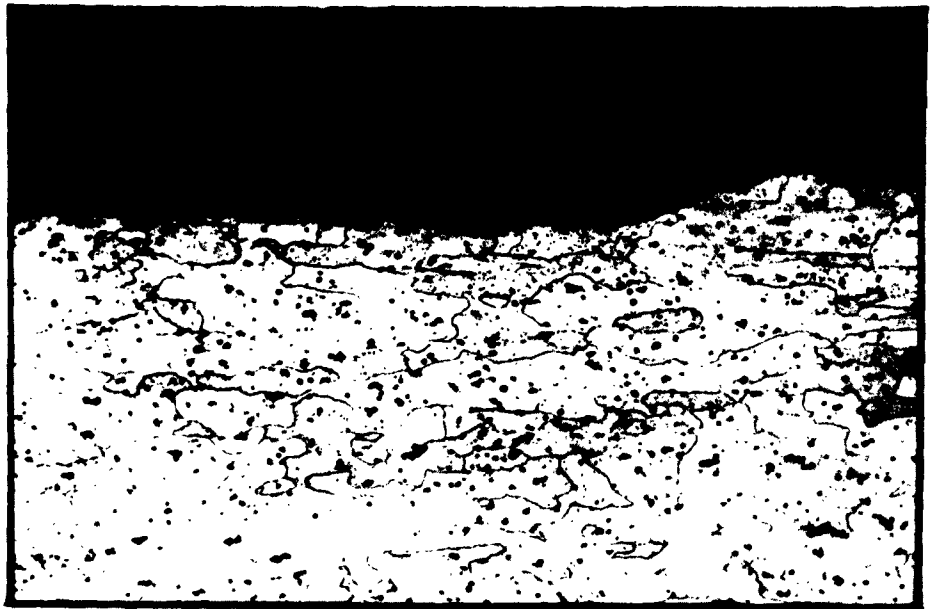
Figure 10. Photomicrographs depicting edge of 1/16 in. thick 2024 T-3 aluminum which had been wetted with 27% Zn - Hg amalgam and held eight hours unstressed before dewetting. Transverse to rolling direction. Magnification 200X.

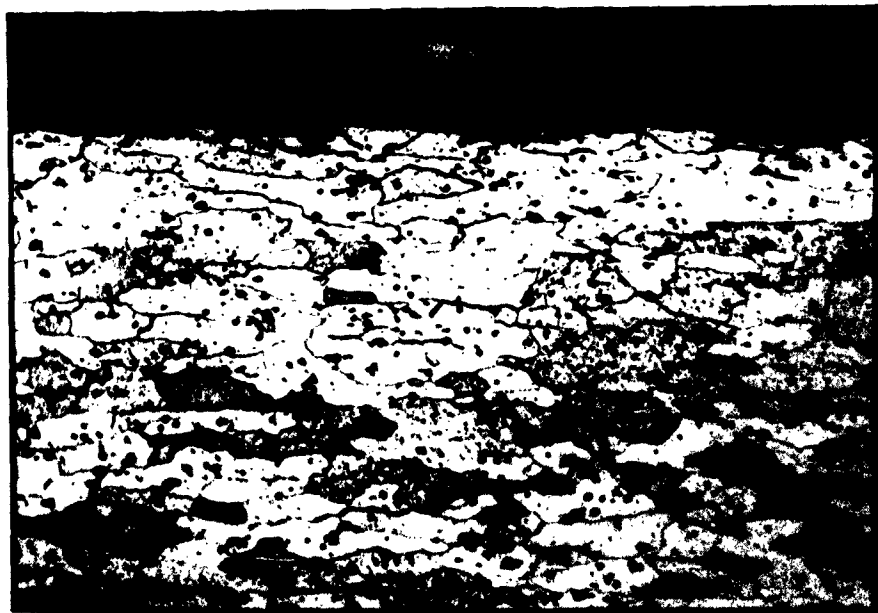
Figure 13. Photomicrographs depicting edge of 1/16 in. thick 2024 T-3 aluminum which had been wetted with 2% Zn - Hg amalgam and held 7 days unstressed before dewetting. Transverse to rolling direction. Magnification 200X.

With longer times of exposure to amalgam, on the order of 48 hours, visible indications of intergranular cracking were noted along the surface of the aluminum. However, no such cracks were detected for the shorter times of exposure. This fact would seem to

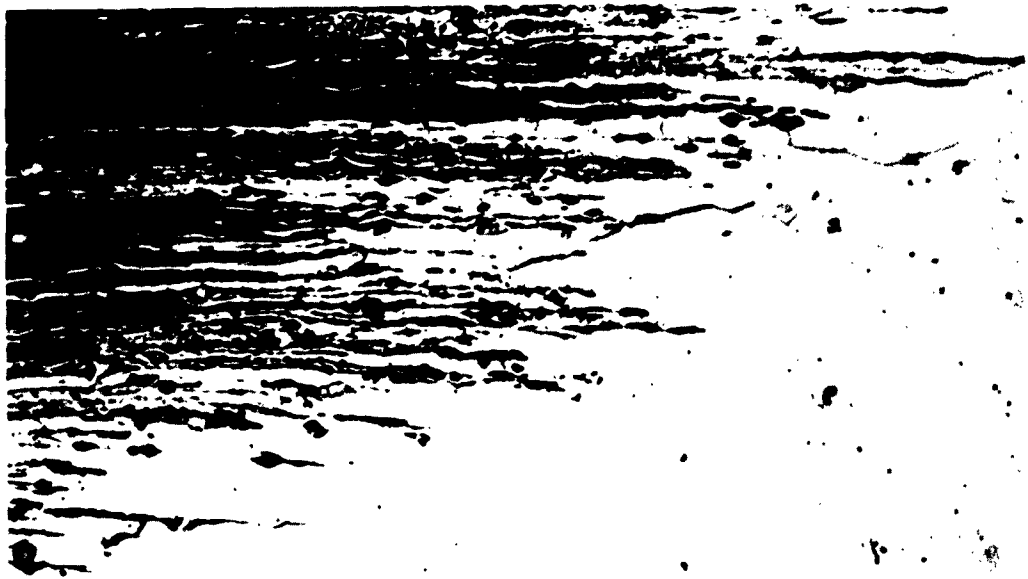
Figure 14. Photomicrographs depicting edge of 1/16 in. thick 2024 T-3 aluminum which had been wetted with 2% Zn - Hg amalgam and held 15 weeks unstressed before dewetting. Unetched.

indicate that increased embrittlement noted with increased time held unstressed is associated primarily with a surface effect and not the result of amalgam penetration into the unstressed aluminum.

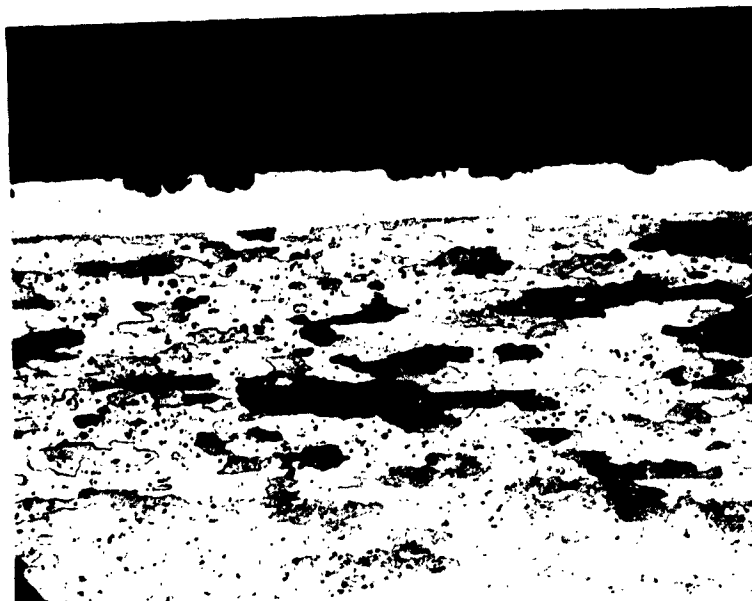
Figure 17. Photomicrographs showing edges of 1/16 in. thick 2024 T-3 Alclad aluminum which had been wetted with 2% Zn - Hg amalgam and ultrasonic probe and held unstressed for times indicated. Note progressive dissolution of cladding. Magnification 100X, Keller's etch.

The time dependence of the wetted fracture strength for the Alclad 2024 T-3 material can best be understood from photomicrographs obtained on the pieces. For short time periods during which the wetted fracture strength was unchanged with time, the amalgam was separated from the age hardened aluminum by the unalloyed cladding. As noted earlier, unalloyed 1100 aluminum shows neither embrittling characteristics nor any decrease in wetted fracture strength with time. Eventually the cladding was in effect removed by dissolution and the amalgam made contact with the base metal so that the process could continue as with the bare age hardened material. The progressive dissolution of the cladding is depicted in figure 17.

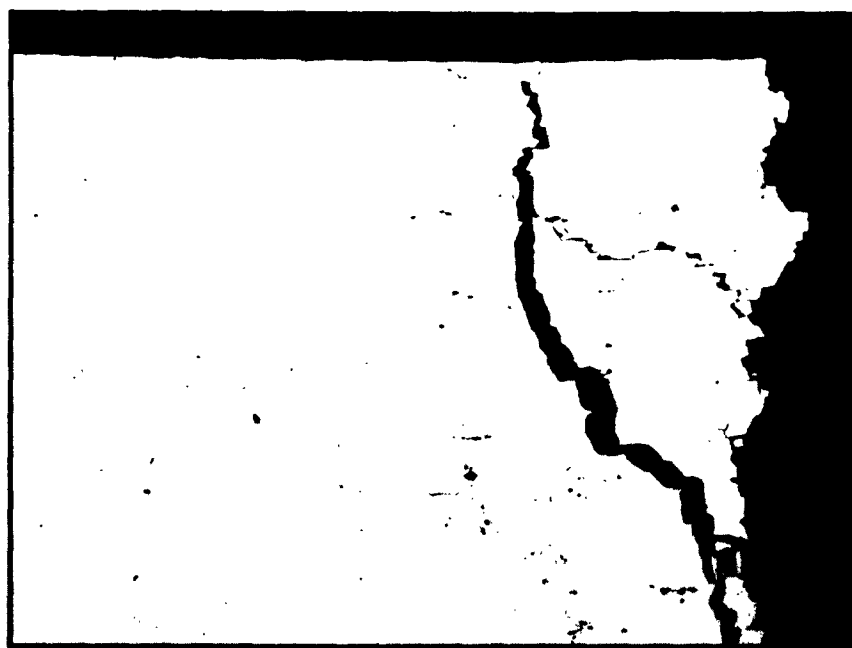
Wetted and tested
immediately

W.F.S. = 46,000 psi

Held 24 hours, wetted,
unstressed before test

W.F.S. = 8000 psi

Figure 18. Photomicrographs of failed edges of 1/16 in. thick 2024 T-3 aluminum sheet specimens upon embrittlement with 2% Zn - Hg amalgam. Note similarity of cracking for specimens which exhibited widely different wetted fracture strengths. Magnification 100X.

differences were seen between specimens which failed quickly upon application of high stress and those which failed at lower stress levels after prolonged holding times. Intergranular and transgranular cracking was evident in specimens from both conditions. Typical photomicrographs for each condition are shown in figure 18.
